Visual Examination of Stents using Microscopy

DYNATEK LABS
Leading the world in medical device testing

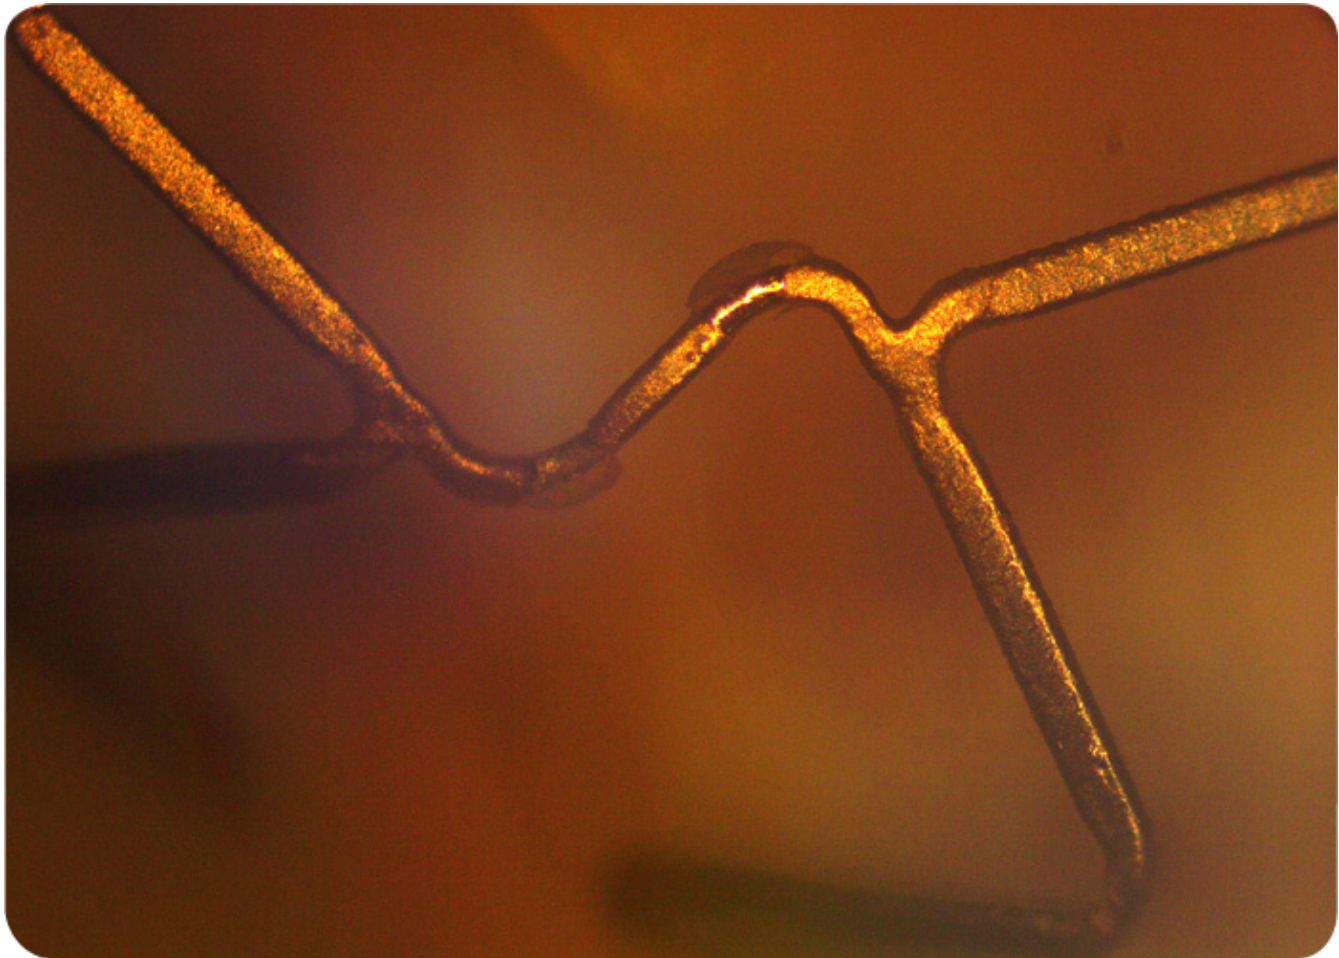
Fig. 1. Blistering of stent coating, 40x

Category B: Anomalies involving nonhomogenous coating (e.g., craters in the coating, wrinkles, blisters)

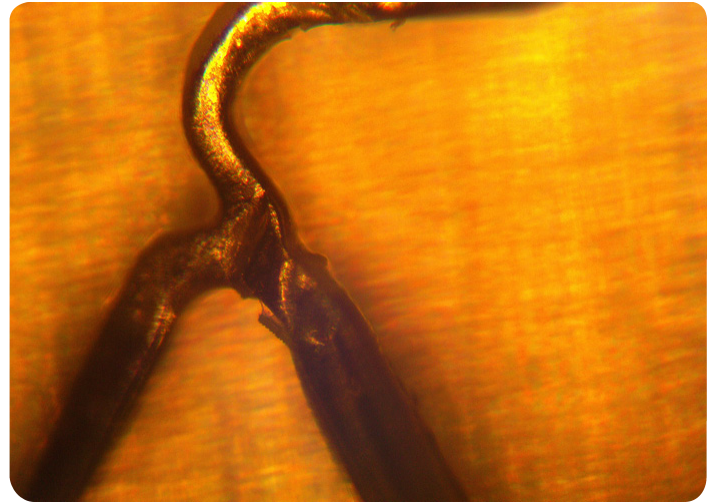
Fig. 2. Peeling and webbing of stent coating, 100x

Category C: Anomalies involving coating displacement (e.g., fragments breaking off, webbing, coating 'bridges' between stent elements)

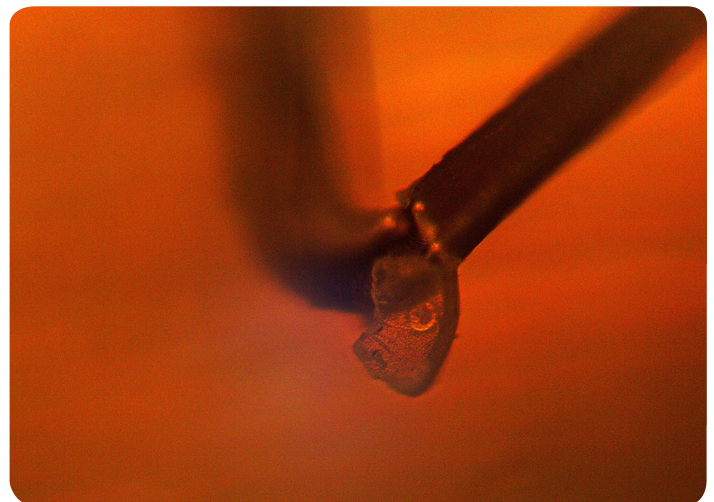
Fig.3. Coating fragment breaking off, 100x
